## CIVIC CENTER DRIVE TREE ASSESSMENT

### TREE REPORT

**CIVIC CENTER DRIVE  
Beverly Hills, CA**

**August 22, 2015**

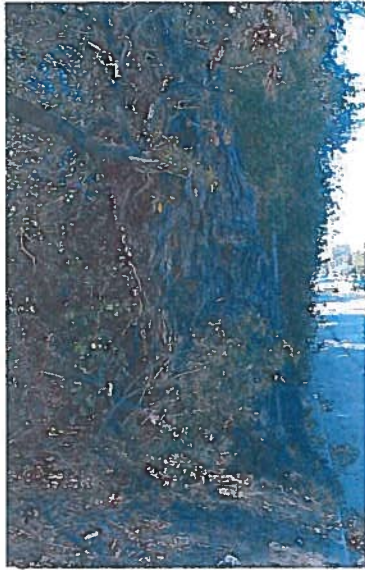
*Eucalyptus trunk over curb*

As a result of their close proximity to the street the Eucalyptus along Santa Monica Blvd. lack a balanced root zone. They also harbor multiple structural defects including weak branch attachments and excessive end weight. Many remnant trunk stumps remain from Eucalyptus already removed, and the remaining trees have either suffered branch failures in the past or harbor hanging limbs now. (See images in Appendix)

7. Consider removal of all of the remaining Eucalyptus along Santa Monica Blvd. at Lot 12. These trees present a potential liability to failure and vehicular impact not rewarded to the value of the property.

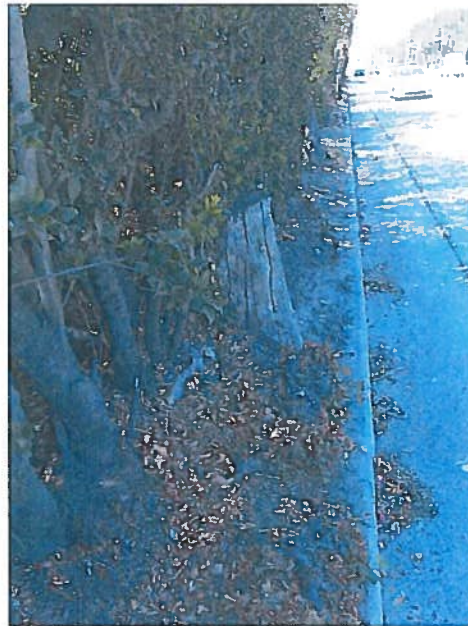
*Remnant Eucalyptus stump at Lot 12*

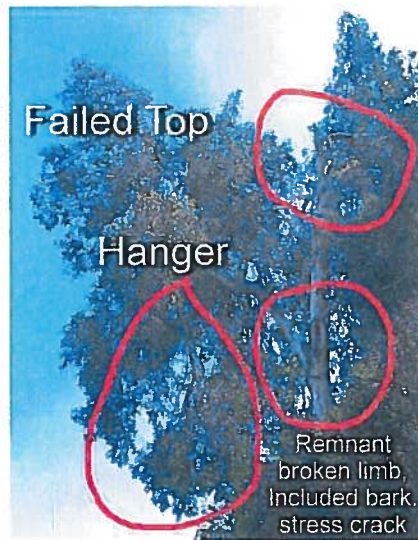
*Eucalyptus overhanging Santa Monica Blvd. with multiple structural defects*

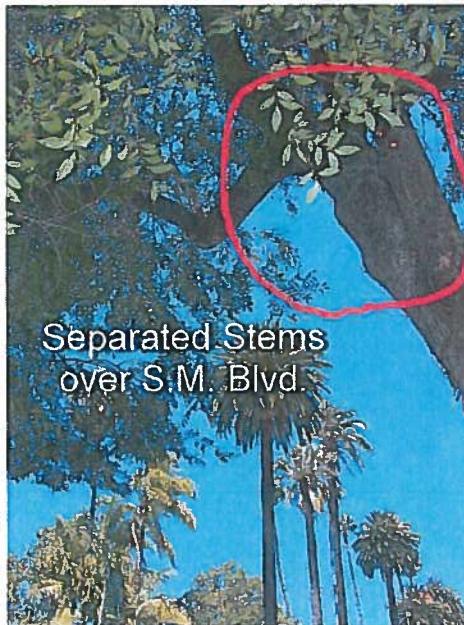
Chinese Elm and Desert Gum are the dominant species along Santa Monica Blvd. Unlike on Lot 12 however, some of the Elms are large trees that overhang the street harbor no serious structural defects. Others however exhibit extraordinary growth habits. One in particular reaches over the street while harboring an unusual split in its trunk separating the two major branches emerging from the central stem.

*Dangerous Elm over S.M. Blvd.*

4. Immediately remove the Chinese Elm on Lot 13 with the cracked main stem, with major limbs overhanging Santa Monica Blvd.
5. Immediately remove the Chinese Elm on Lot 13 with the unnatural pattern of wounding. This tree harbors quite a few limbs that hang over Santa Monica Blvd., and its structural integrity is impossible to measure.

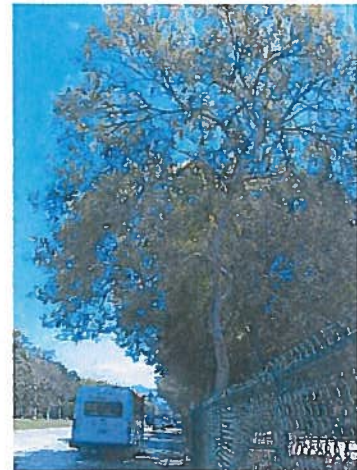
A couple of smaller Elm Trees exude highly unusual growth patterns. The pattern of growth on one large tree close to the curb reveals intermittent wounds along its trunk and large branches although the wounds seem to emerge naturally, not associated with any damage from pruning or impact. Another's trunk, rather than cylindrical ascends the tree in a diamond type pattern. This particular tree is rather small, and lies approximately 6' inside of the fence.

*Lot 13 Elm on Santa Monica Bl.*

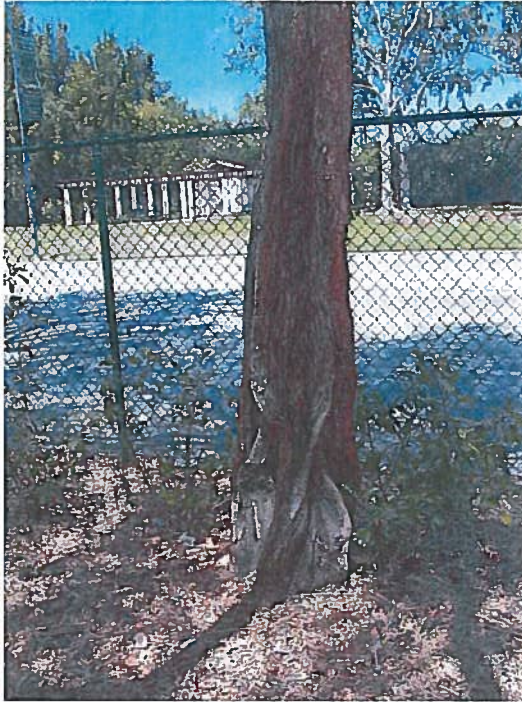
*Deformed Elm on Lot 13*

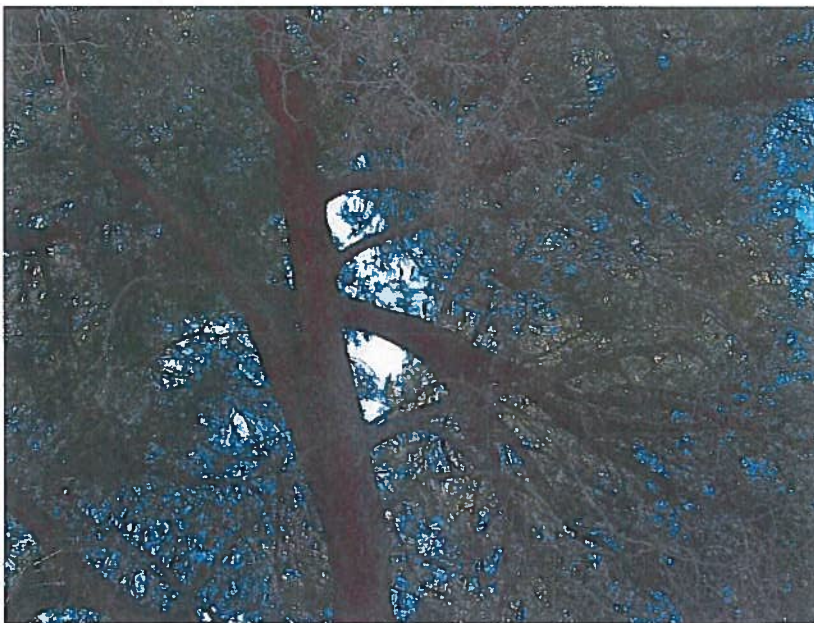
Ultimately, at the northeast corner of Lot 13 lies an enormous Aleppo Pine (*Pinus halepensis*). This tree rests in a natural state, appearing never to have been pruned. The foliage reaches virtually to the ground except where it reaches over Santa Monica Blvd. Structurally this tree defies physics and harbors such defects as inverse taper, co-dominant stem growth and included bark.

*Unbalanced structure of Aleppo Pine over S.M. Blvd.*

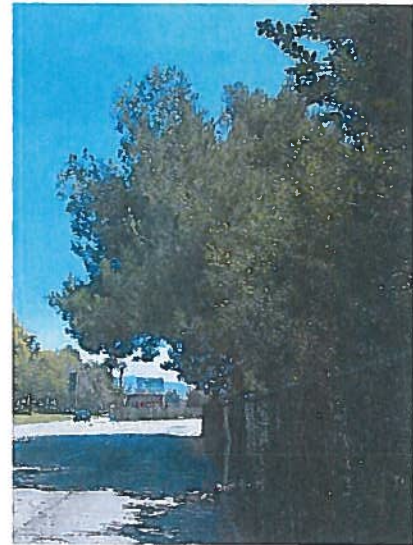
*Aleppo Pine over S.M. Blvd.*

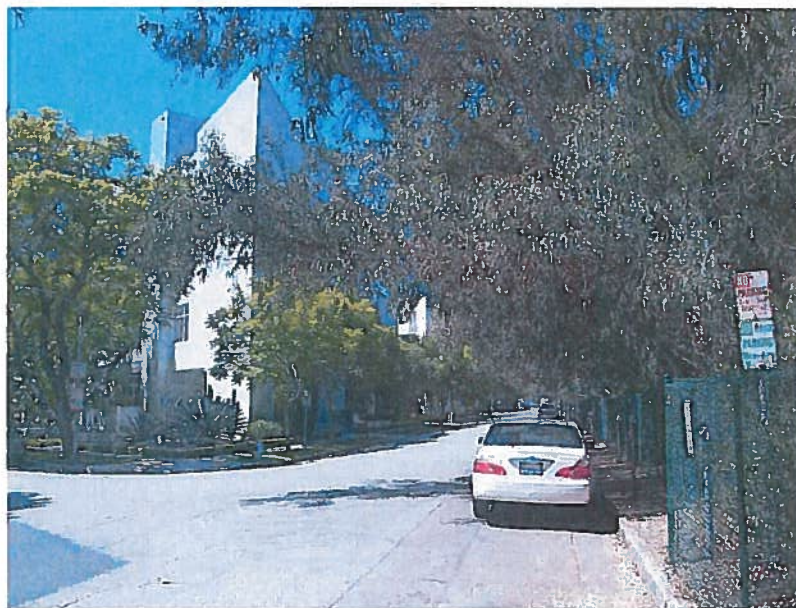
overhang the parking area or street. Moving west, two (2) rows of a Eucalyptus species (*Eucalyptus globulus 'Compacta'*) run parallel to the street. The row closest to the sidewalk overhangs both the parking area and the street. These trees exhibit numerous structural defects; including poor limb attachments, buried root crowns, inverse taper, excessive end weight, trunk deformation and stress cracks. Although many harbor foliar damage from a common predator, (Tortoise Shell Beetle) the damage is neither structural nor a serious source of stress. Despite limited supplemental irrigation the foliage reveals little if any symptoms of drought stress. The interior row of Eucalyptus is generally smaller than the row planted most closely to the sidewalk, but a few of the trees have long arching stems that were they to fail could cross the street. The interior row of trees, unlike all of the others are planted on a manufactured berm. All of the root crowns of these trees are buried.

*Eucalyptus overhanging Civic Center Drive*

6. Immediately remove long, poorly attached limbs overhanging Civic Center Drive on Lot 13. These precarious limbs could fail at any moment, and appear to be attracting people to park their cars beneath them for the shade they provide.

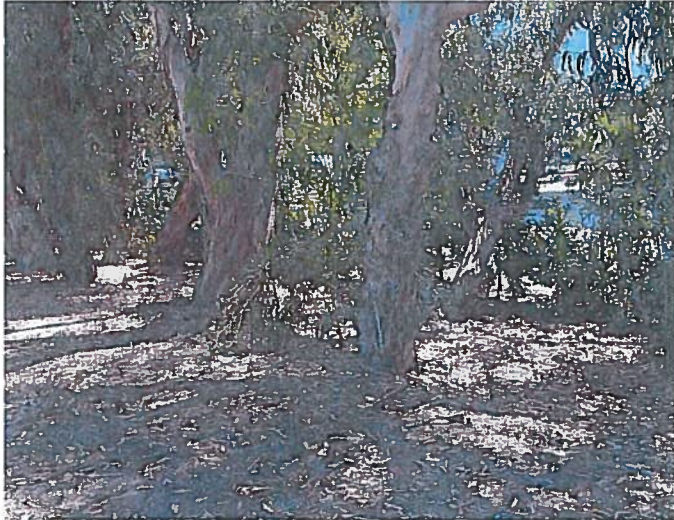
*Buried root crowns of interior row of Eucalyptus*

Unlike the trees planted along Santa Monica Blvd. on both Lot 12 and Lot 13 the Eucalyptus along Civic Center Drive, particularly those planted on a mound in the interior row suffer from buried root

crowns. One can readily observe the reduced diameter of the trunk where emerging from the soil in comparison to that a few inches above the finish grade.

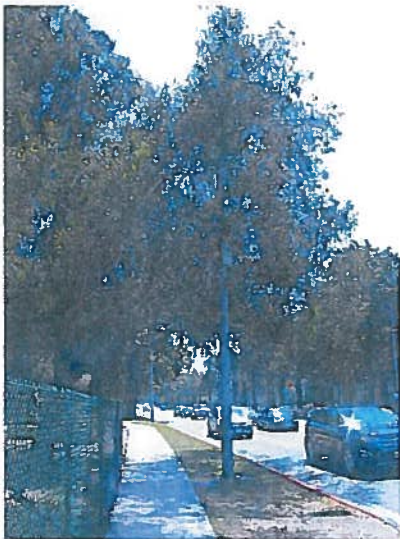
A few of the branches of these trees precariously overhang the sidewalk and high traffic areas. One particular tree, at the westerly corner of the parcel overhangs the sidewalk at both Civic Center Drive and Beverly Blvd. Multiple branches extend over this passage-way with extremely poor attachments and no secondary or tertiary growth.

*Dangerous Eucalyptus overhanging sidewalk*

3. Immediately remove the defective Eucalyptus limbs overhanging the sidewalk at the corner of Beverly Blvd. and Civic Center Drive to protect pedestrians and vehicular traffic.

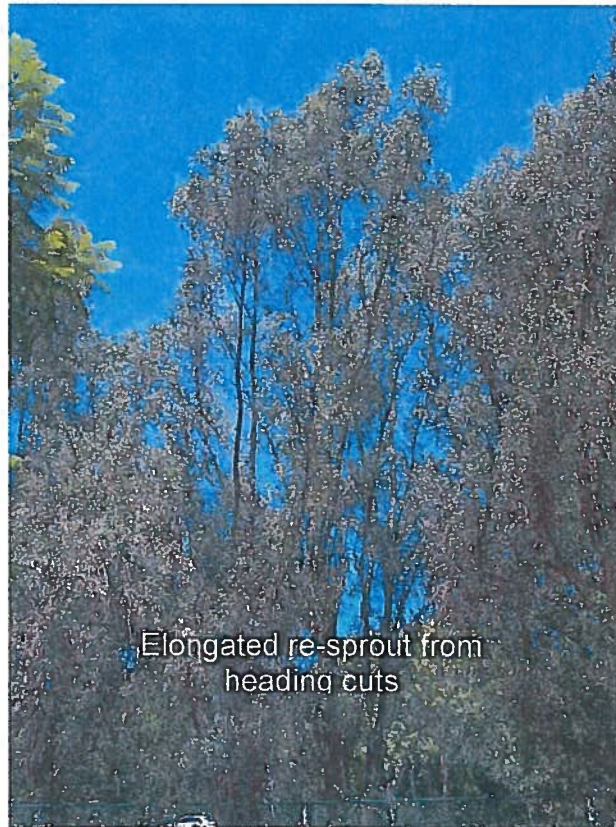
Other trees, both on the exterior and interior harbor stems emerging from prior pruning cuts that extend 30' - 40' from the original cut/wound with no secondary branching and thus minimal taper.

Elongated re-sprout from heading cuts

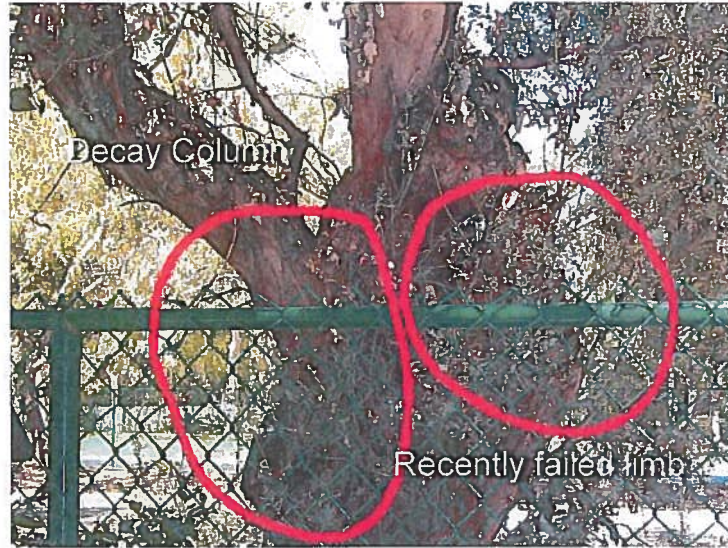
*Multiple branches emerging from decayed stem after 2-branch failures*

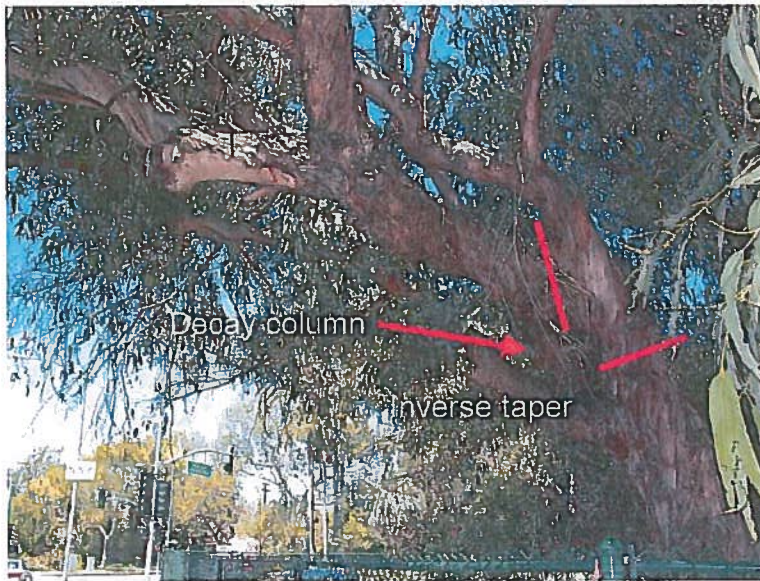
*Eucalyptus overhanging Beverly Blvd. sidewalk*

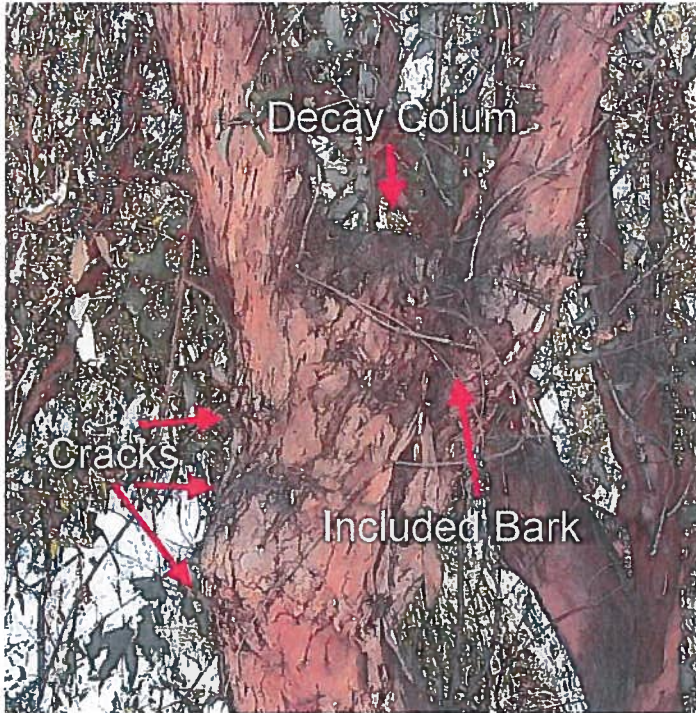
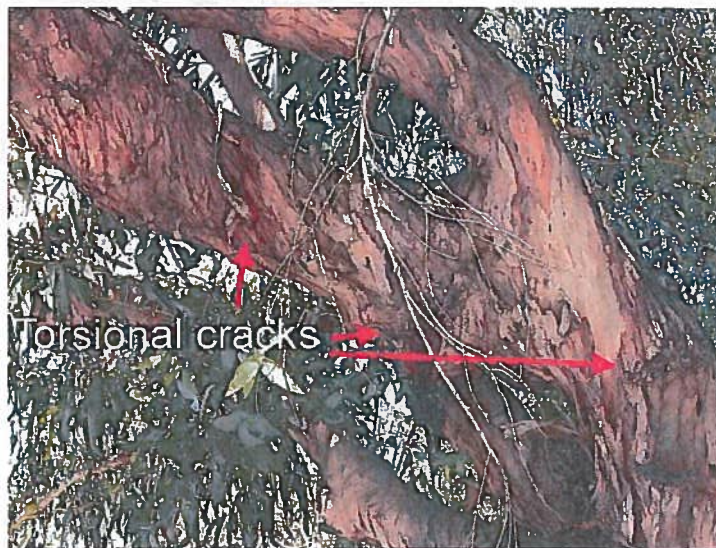
*Close up of branch overhanging Beverly Blvd. sidewalk*

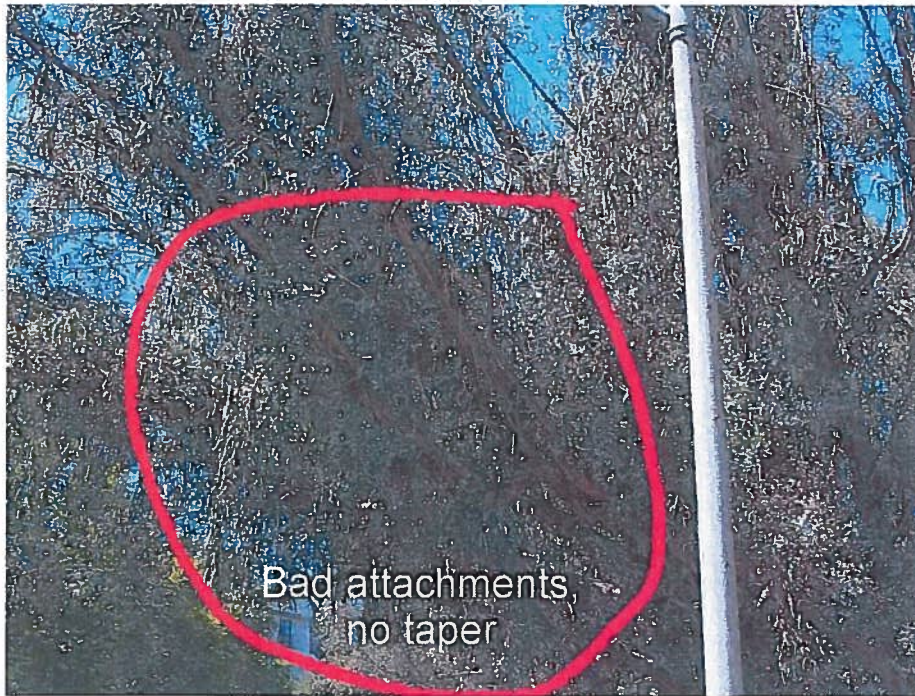
*Typical tree overhanging Civic Center Drive at Lot 13*

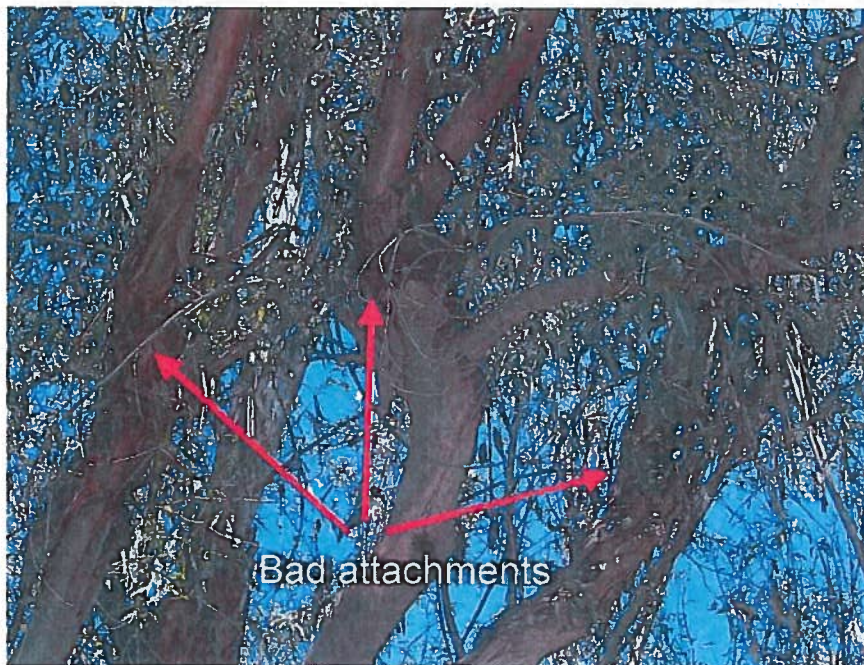
*Emergent branches attached to decayed stems, typical of improper heading cuts*

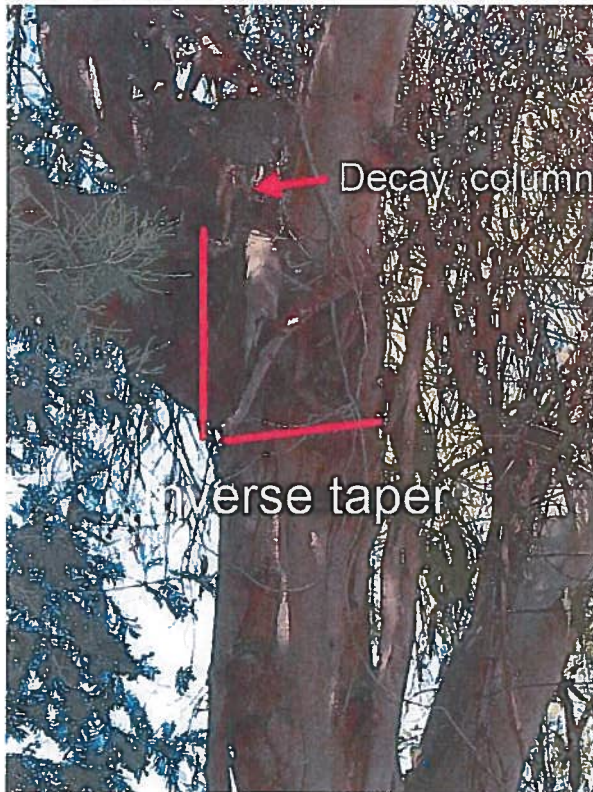
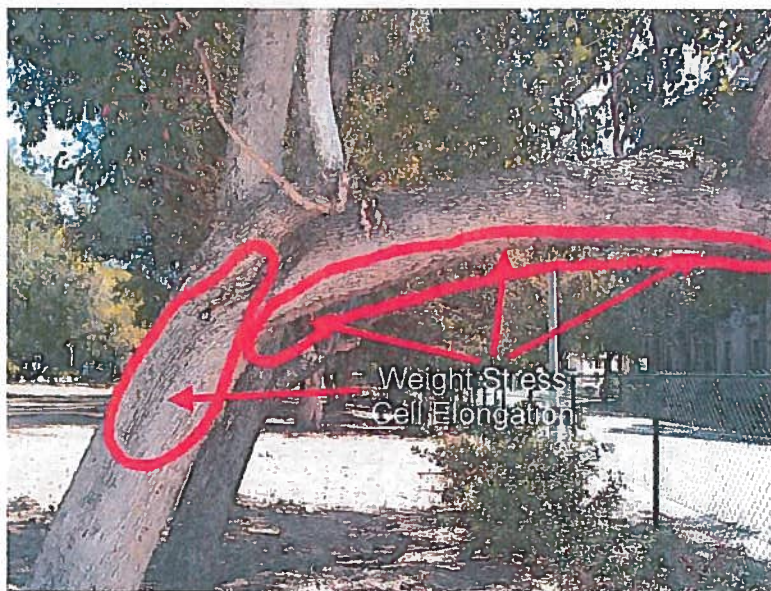
*Distorted, leaning Eucalyptus overhanging Civic Center Drive*

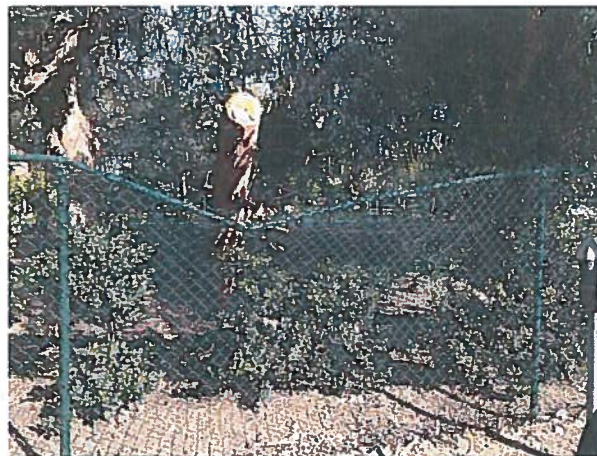
When the natural pattern of growth is interfered with, particularly associated with improper pruning, trees can grow in unpredictable, unbalanced ways. Most of the Eucalyptus on this property suffer from this condition described in this report as *inverse taper*. The issue of inverse taper is that physically, the emergent branch is larger (in diameter) and heavier than the stem it is attached to.

*Recently failed Eucalyptus on Civic Center Drive with inverse taper*

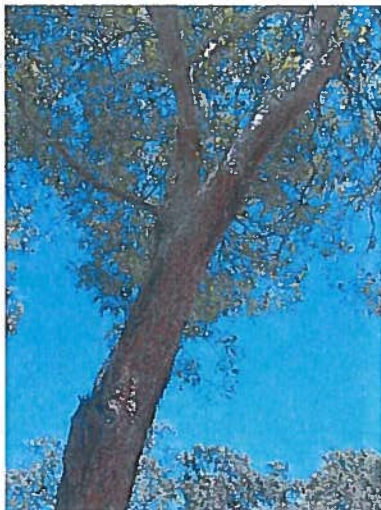
Two Chinese Elms, close together along Santa Monica Blvd. on Lot 13 exhibit extremely unusual growth patterns, already referred to in this report. My only experience with such rare, distorted

growth habits has been associated with trees growing in soil contaminated with paints, solvents, turpentine, or heavy concentrations of metals. Knowing this corridor of land once harbored a railway it is possible that some of the soil has been contaminated. Perhaps this explains the lack of tree or plant material growth along the easterly portion of Lot 13 along Santa Monica Blvd.

*Pattern of unnatural wounds on Chinese Elm at Lot 13*

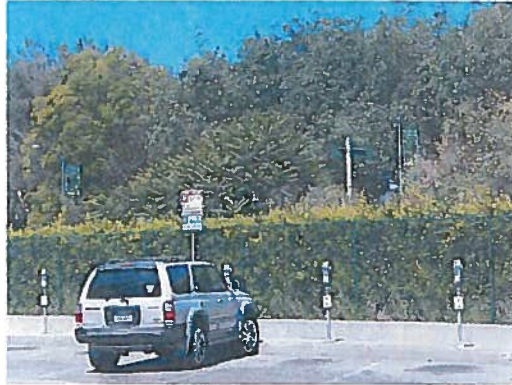
The nuisance tree is the *Ailanthus altissima* at the west corner of Lot 12. This species readily spreads by movement of its very fine textured seed. The seed can spread by wind, or via bird droppings. Some believe it was brought to the Americas and to Europe via Chinese laborers constructing rail lines. Some suspect that the fine seeds embedded themselves in the pockets of these laborers and spread when clothing was washed in rivers adjacent to the rail lines. It is true that this species can be observed along train routes in both Europe and North America. This species is designated as *INVASIVE* by both the United States, and California.

**Lot 12 Civic Center, Ailanthus**

1. Immediately remove the invasive *Ailanthus altissima* at the western corner of Lot 12
2. Immediately remove one Chinese Elm on Lot 12 along Santa Monica Blvd. to remove the danger presented by a tree whose main trunk has failed, which has suffered two (2) recent, large branch failures, and currently harbors a broken branch suspended over the street.
