# CITY LANDMARK ASSESSMENT & EVALUATION REPORT

## UNION 76 SERVICE STATION

427 North Crescent Drive, Beverly Hills, CA (9376 Santa Monica Boulevard)

# CITY LANDMARK ASSESSMENT AND EVALUATION REPORT

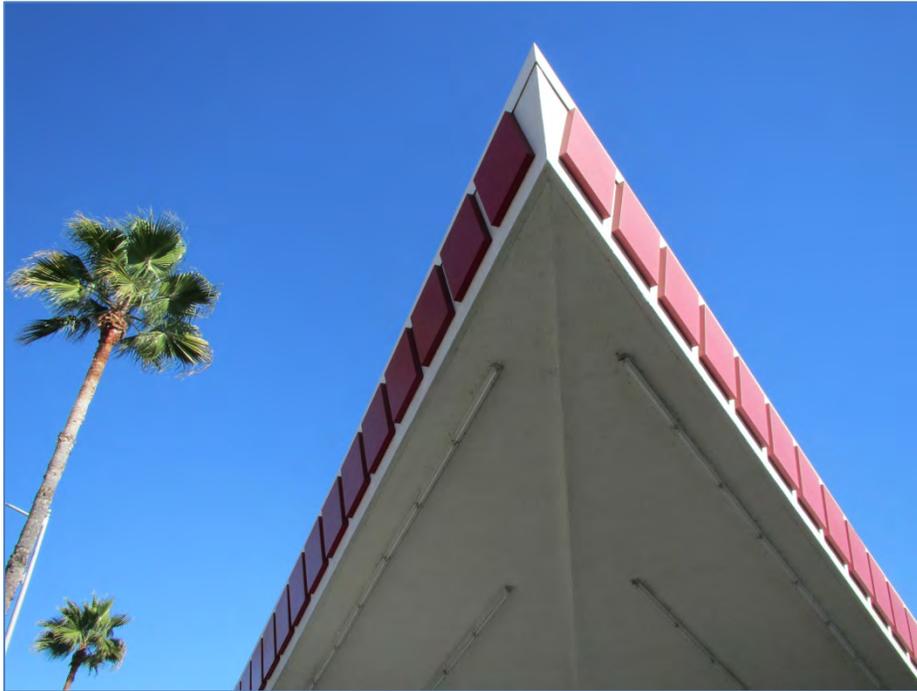
PHOTO - 9: Canopy detail. September 2013.

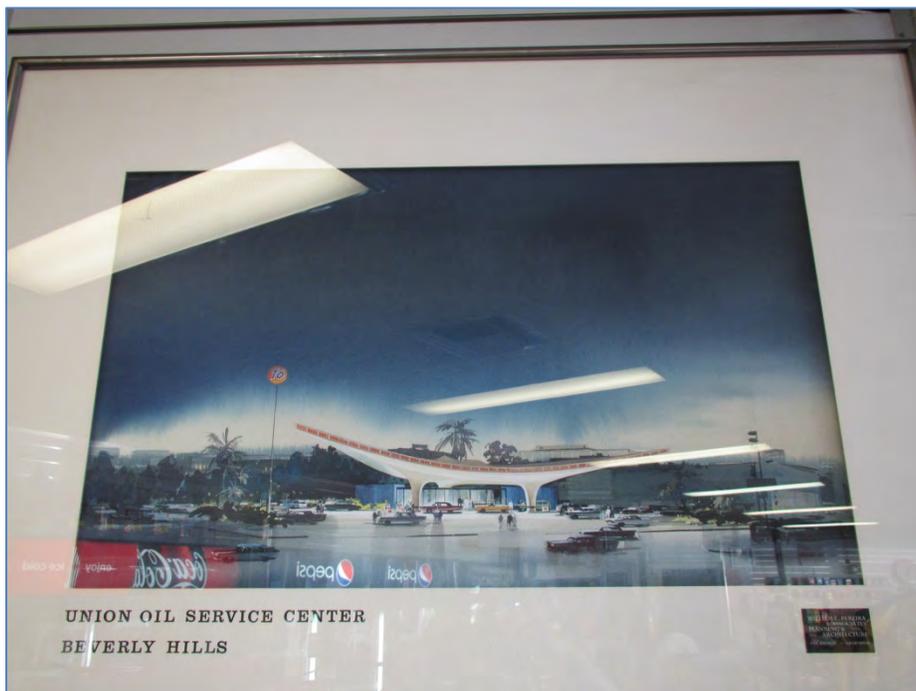
PHOTO - 10: Architect's original rendering, displayed in office of gas station.

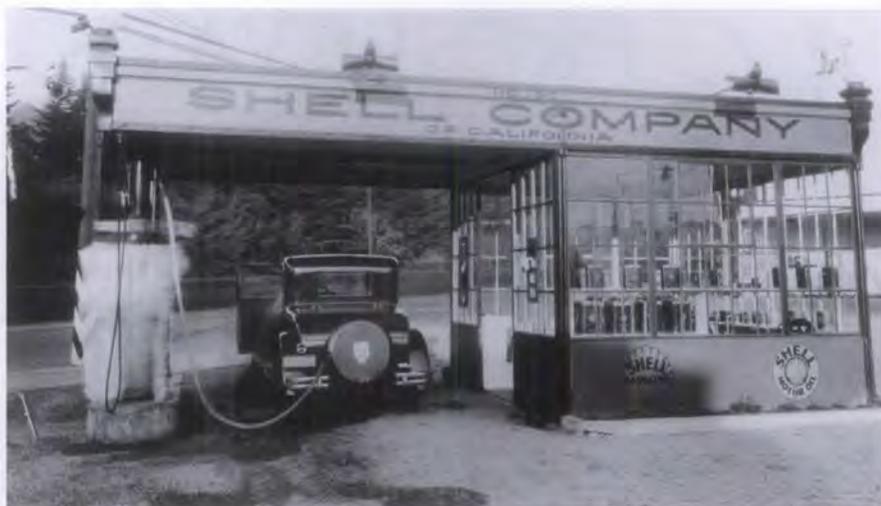
Figure 3. This shed-type station with its prefabricated steel panels, pump island, and canopy prefigured many later gas station designs. Photo: American Petroleum Institute Photograph and Film Collection, Archives Center, National Museum of American History, Smithsonian Institution.

**Shed-Type Stations.** Detached structures built specifically for the sale of gasoline appeared during the second decade of the twentieth century in an effort to meet the petroleum demand generated by the Ford Model T and other affordable automobiles. In the initial race to expand, companies and independent operators constructed basic sheds to serve as drive-in filling stations. Many were rudimentary frame shacks with wood or corrugated metal exteriors. More substantial designs featured prefabricated metal panels, industrial steel windows, and some limited ornament. In either case, the shed was a utilitarian building used for storage and office space, and to shelter the station attendant. Pumps were placed immediately adjacent to the structure or separated on the lot by a driveway where cars parked to refuel (Fig. 3).

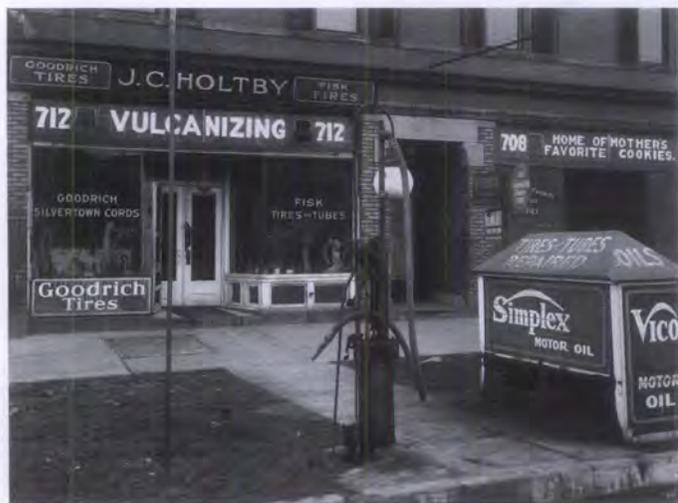
Figure 2. Although hardly an ideal sales system, pumps and underground tanks along the curb were an improvement over the earliest filling stations where gasoline was poured from hand containers. Photo: Utah State Historical Society, used by permission, all rights reserved.

car dealers, grocery stores, hardware stores, and other businesses contracted with refiners, installed pumps out front, and sold gas along the curbside (Fig. 2). Soon, the dramatic increase in car ownership led oil companies and entrepreneurs to introduce what we now commonly refer to as gas stations. Over the next hundred years, the gas station took many forms reflecting the ebb and flow of popular design trends, the growth of the petroleum industry, and a procession of new services and formats, from car washes to mini-marts. Though the evolution of gas station forms seen throughout this history is quite varied, a number of general types have been identified.<sup>1</sup>

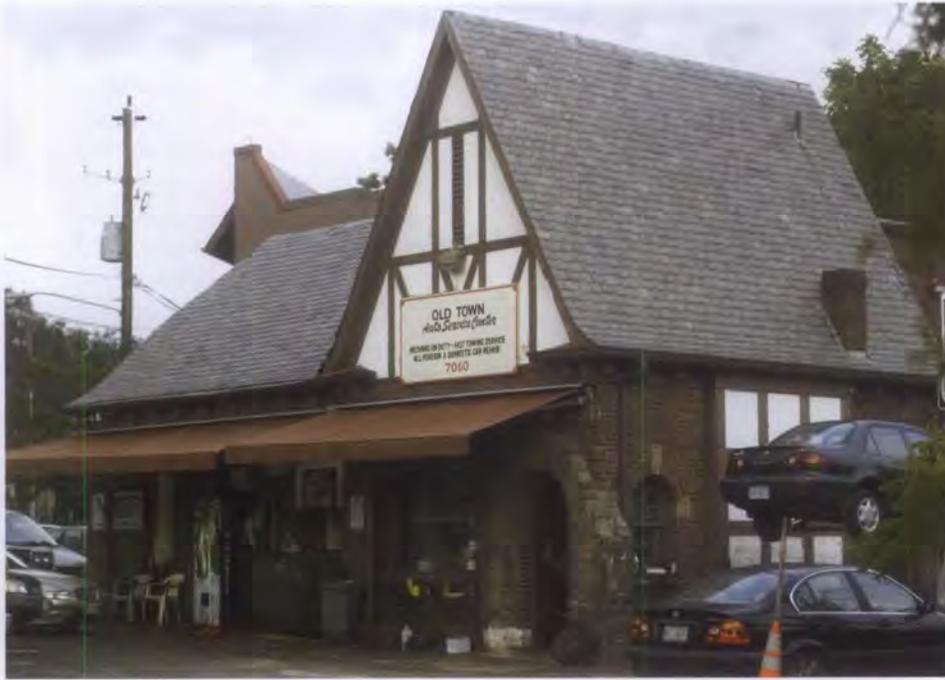
Figure 4. Designs based on popular domestic forms helped stations blend in with residential neighborhoods while imparting a sense of stability and permanence. This Tudor Revival station was converted for use as a repair shop with virtually no change to the structure or site.

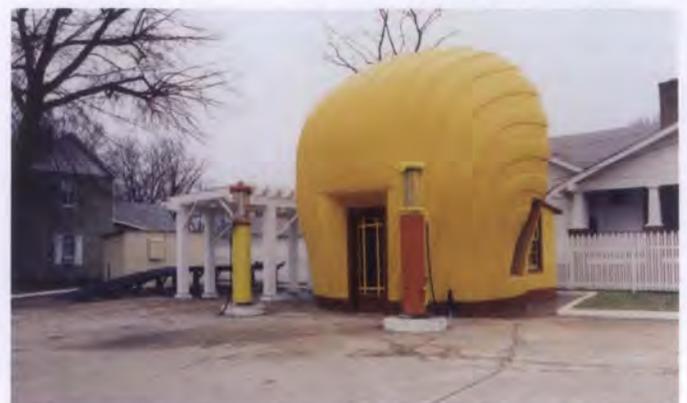
Figure 5. This 1936 Shell station in Winston-Salem, NC, is an example of a programmatic design, meant to attract attention and stick in the customer's mind. It was recently rehabilitated to serve as a field office for Preservation North Carolina. Photo: Preservation North Carolina.

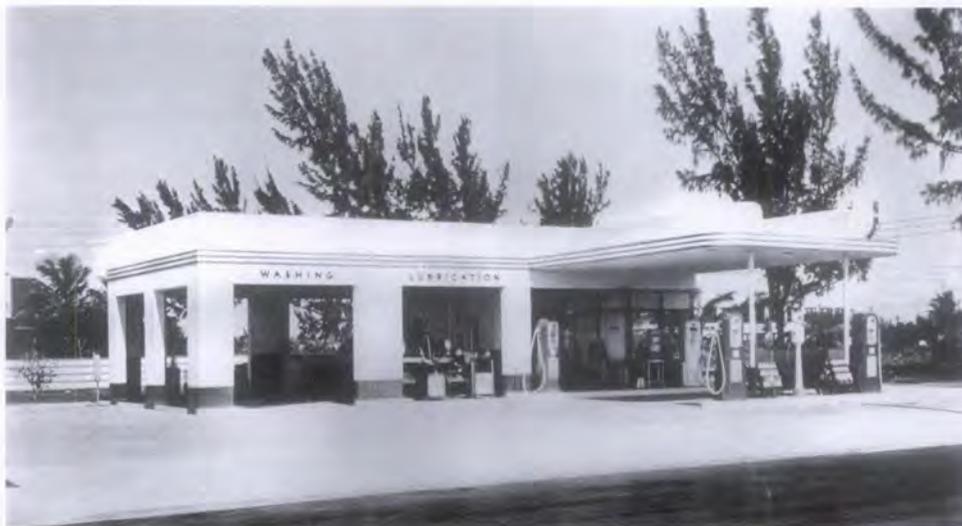
Figure 6. Box-type stations often incorporated Art Moderne forms such as this design's rounded corners, stripes, and large sales windows. Photo: American Petroleum Institute Photograph and Film Collection, Archives Center, National Museum of American History, Smithsonian Institution.

The form and layout of box stations were also influenced by current economic conditions. Pushed during the Great Depression to explore other revenue streams, station owners added service and repair bays (emphasizing the characteristic rectangular footprint of box stations) as well as expanded sales areas to market lucrative car tires, batteries, and accessories. Large display windows and glazed service bay doors highlighted these products and services (Fig. 6).

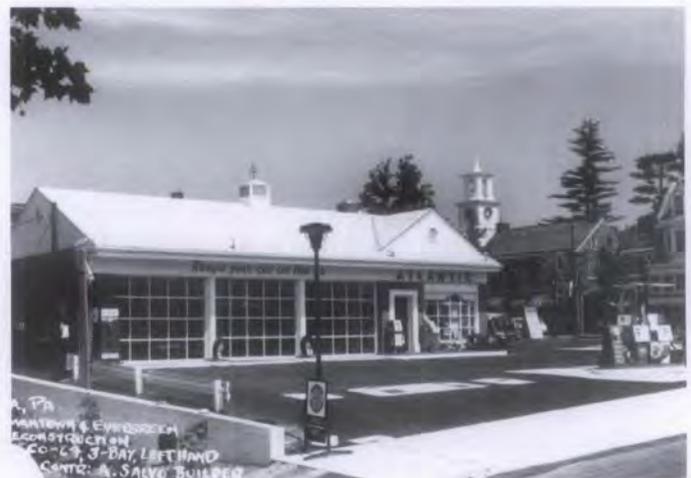
Figure 7. During the 1960s existing box stations were often remodeled and new stations were designed with Colonial Revival or Ranch house details. Photo: American Petroleum Institute Photograph and Film Collection, Archives Center, National Museum of American History, Smithsonian Institution.

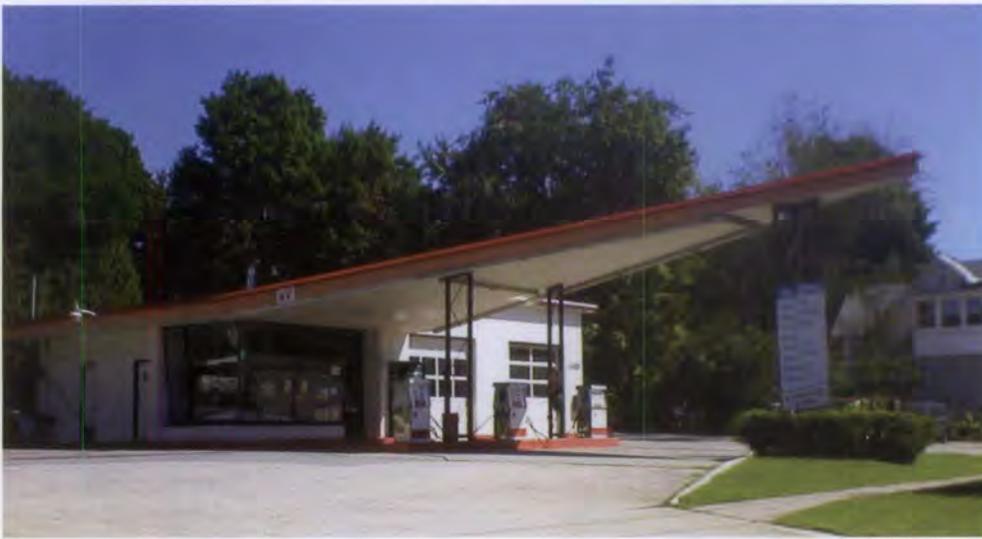
*Figure 8. This former Phillips 66 gas station in Burlington, VT, sports a quintessential stylized box design. Its space age canopy is visible from far down the road. Photo: Devin A. Colman.*

Although form and decoration vary, most historic gas stations share a number of features that help define their character. These features can identify a particular structure as belonging to a common gas station type, like the clinker bricks used on Tudor house-type designs. Alternately, features may accentuate the uniqueness of a particular structure, such as a custom roof design or circular plan. Some features were highly unusual when first adopted, later became unexceptional, and today are once again rare and distinctive. A prime example is the V-shaped canopy found on postwar Phillips 66 gas stations (Fig. 8).

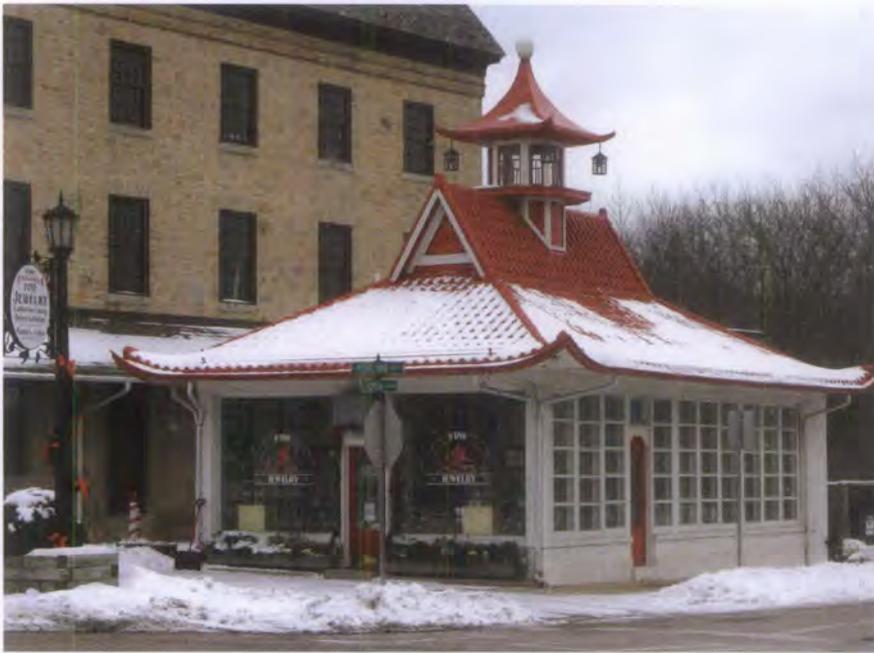
Figure 9. The dominant feature of this former gas station (1929) in Cedarburg, WI, is its pagoda-style metal tile roof (complete with upturned eaves and Japanese lanterns suspended from the cupola). The building currently functions as a jewelry store. Photo: Kenneth M. Itle, Wiss, Janney, Elstner Associates, Inc.

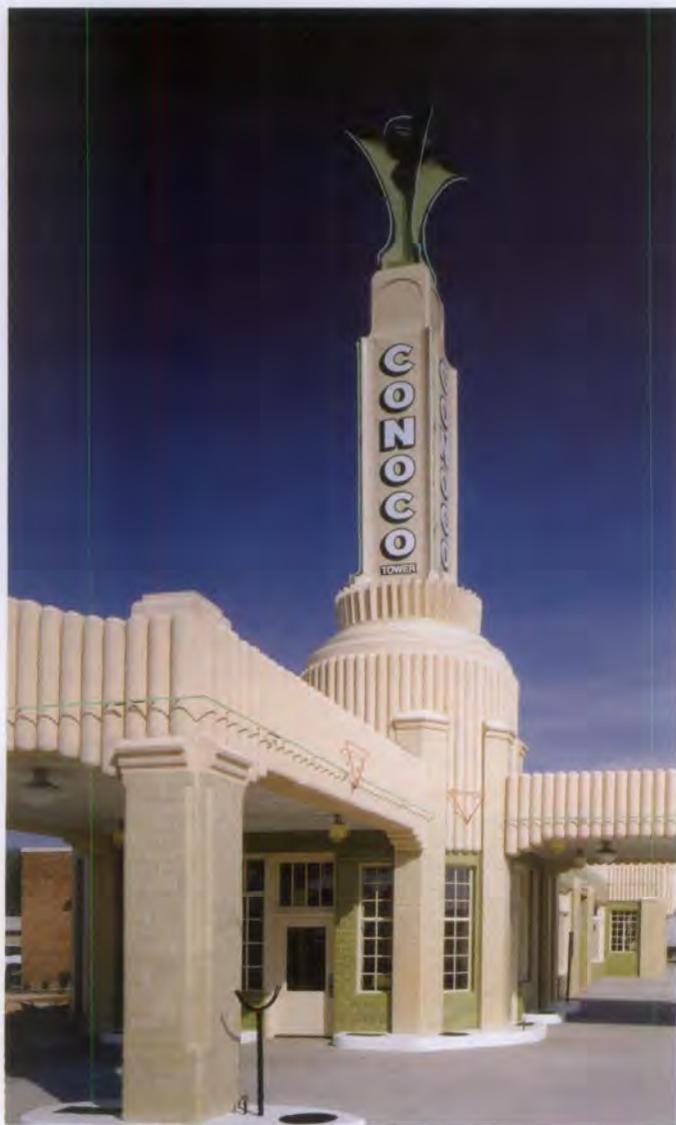
Figure 10. The canopies on this 1936 gas station in Shamrock, Texas, are both functional and integral features of the station's overall design. This building was recently converted for use by the local Chamber of Commerce, partially with FHWA Transportation Enhancements funding assistance. Photo: Mark Trew Photography.

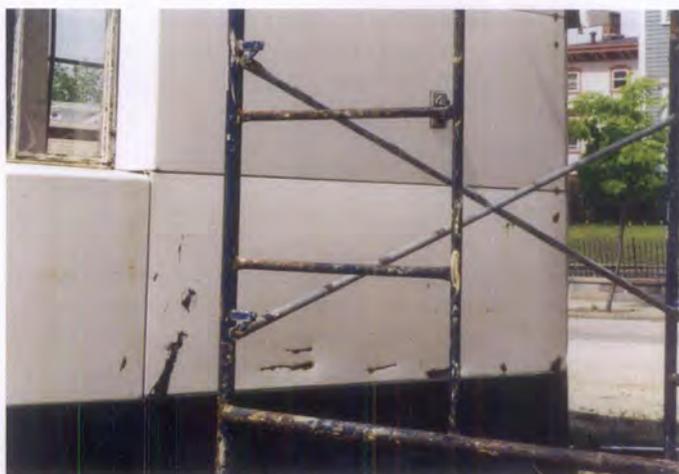
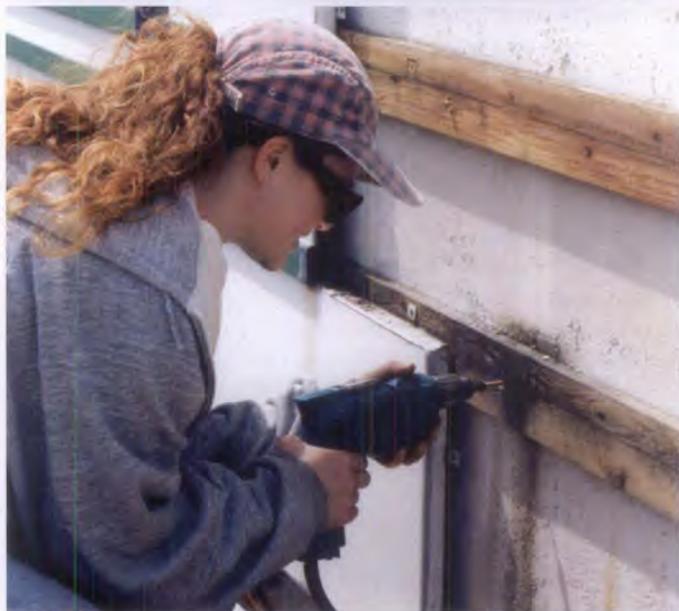
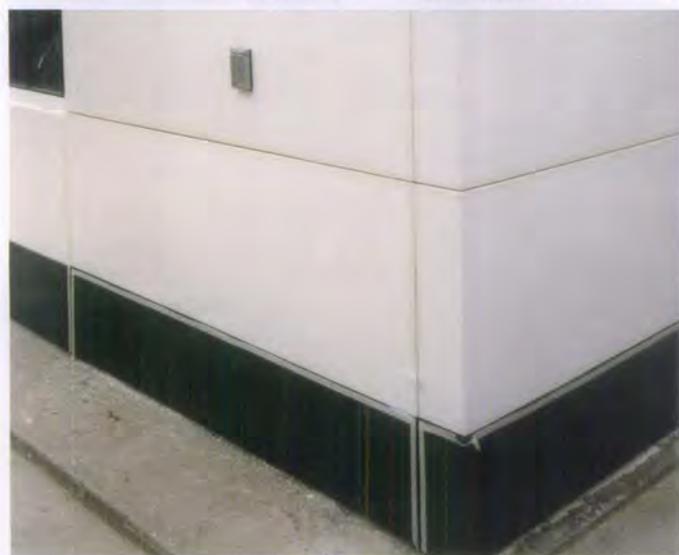
Figure 11. The porcelain enamel facade of this former Texaco station (1960) had numerous dents and scratches that had exposed the steel beneath the enamel to deterioration (top). Rehabilitation work included repairing localized damage to the panels and blending patched areas to match adjacent historic material, replacing sleepers beneath the panels (center), replacing severely damaged panels with like material, and recaulking the joints (bottom). Photos: John Vaughan, Architectural Conservation Services.

Porcelain enamel offers a good example of some of the problems and the level of skill and experience that may be required when repairing historic materials (Fig. 11). Spot repairs of damage (drill holes, impact damage) to these types of manufactured panels are challenging. Because the original glass-like finish was baked on at a high temperature, it is hard to adhere filler and paint to the enamel surface; blending new material with the original surface color is particularly difficult. The preferred, least intrusive, approach is to remove any rust, fill any depressions with a marine epoxy filler, prime, and repaint the surface with a high-quality glossy enamel. This paint coating will likely require a renewed treatment after some years. More severe damage may require replacement with a salvaged or newly fabricated panel. Where panels are loose or select ones need replacement, care should be taken during disassembly as they often are supported by an attachment system that requires a specific sequence of removal and reinstallation.

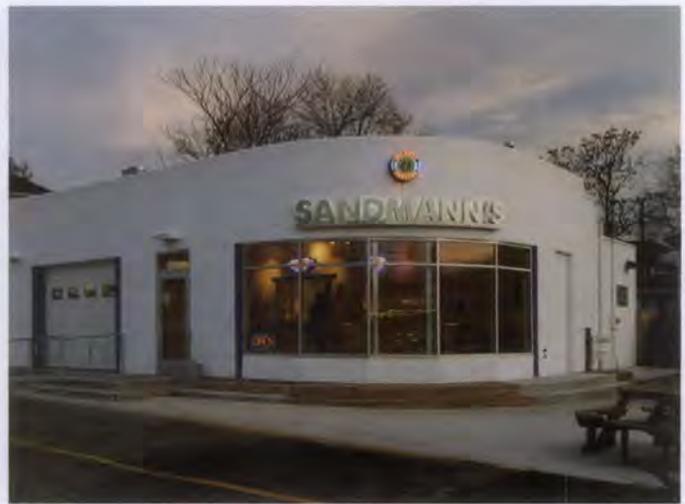
*Figure 15. The historic restroom door to the right of the display window was closed off (and entry provided on the inside) when this former gas station in Grand Rapids, MI was converted to a carry-out restaurant. A flush panel was recessed in the opening to identify the historic location of the door. Photo: M Buck Studios.*

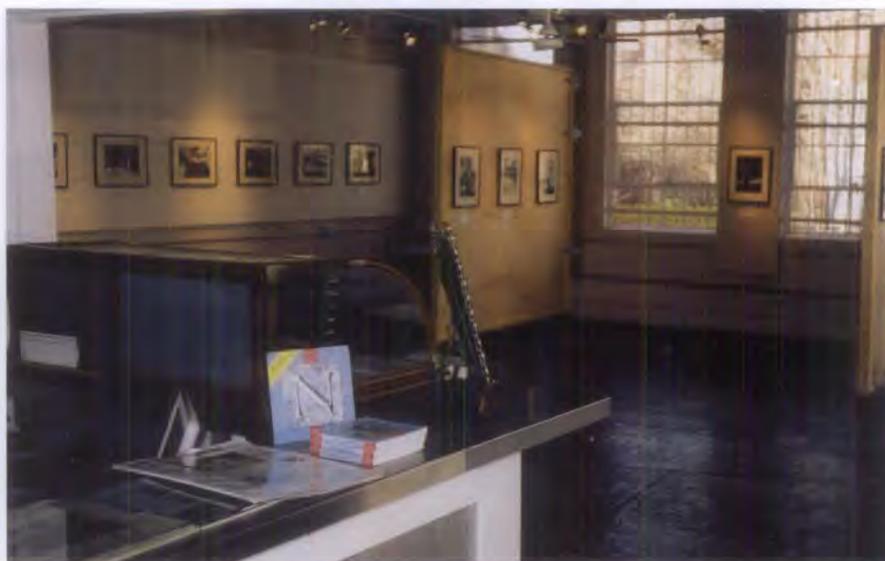
Figure 16. A postwar Stylized Box-type station in Newport, RI, was rehabilitated and converted to an art gallery. The service bays (here showing side and rear walls) provide open gallery space while the small sales area (left) continues its historic retail function.

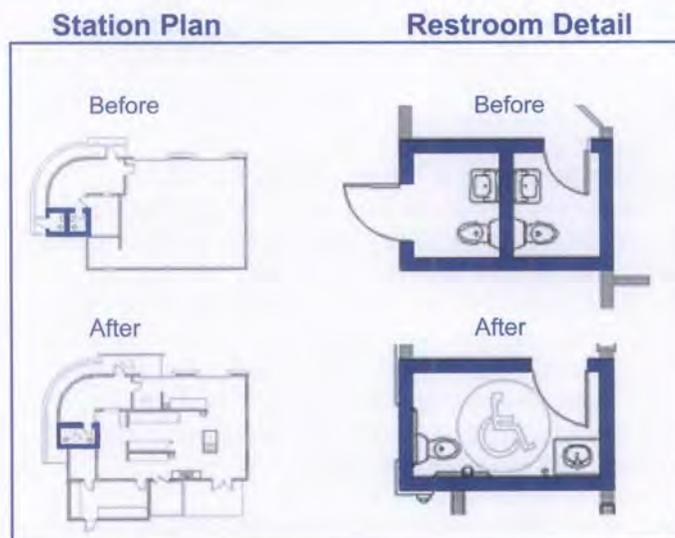
Figure 17. A plan of the same station shown in Figure 15, illustrates how the historic men's and women's rooms were combined to make a single accessible restroom. Drawing: Lott3Metz Architecture.

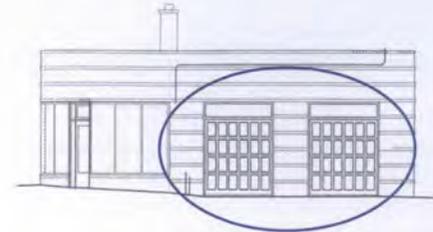
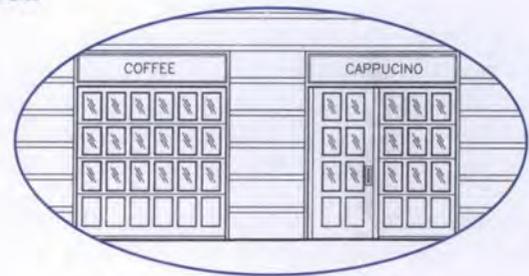
*This 1938 concrete block gas station featured a pair of wood multi-light segmental service bay doors (top). When the station was converted to a coffee shop the service bays were reused as a dining area. The doors were fixed in place and a door for customers was introduced in the right opening in a manner that retained the original light configuration (above). To increase the thermal properties of the service bay doors, the single pane glass was removed and replaced with insulating glass (below). The appearance of the door is virtually unchanged and the building retains its historic character. Drawings courtesy Robert Olin, Sherman Perk.*

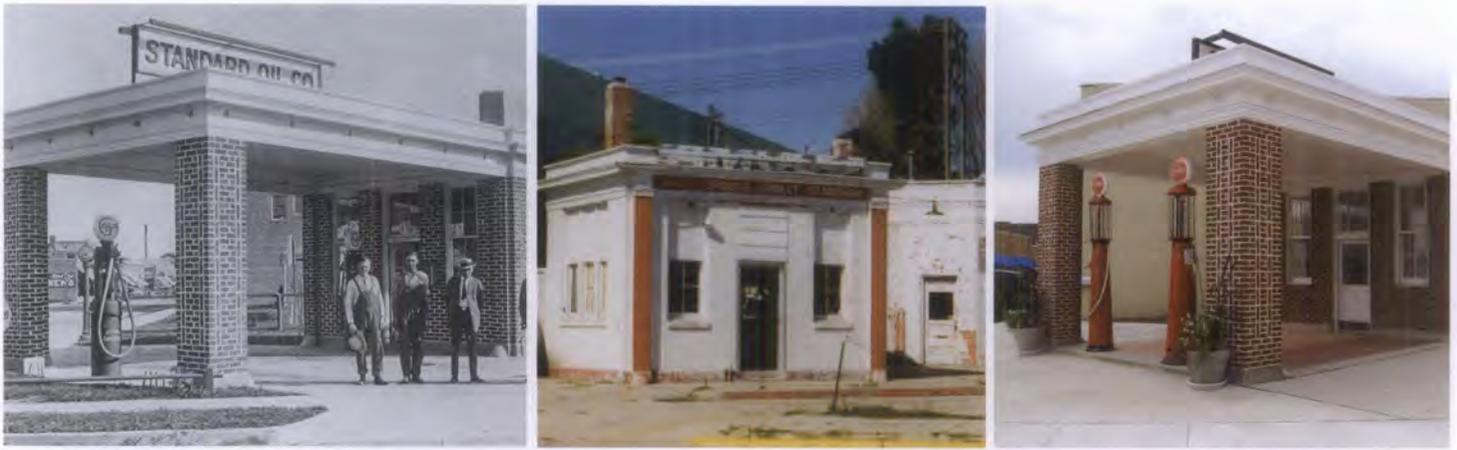
Figures 18. The canopy of the 1920s Spruce Street Station in Ogallala, NE, was an important feature that contributed to the building's character (left). When recently purchased for rehabilitation the canopy had long since disappeared (center). Using photographic and physical evidence, the canopy was reconstructed to match the building's original appearance (right). The station currently functions as a Main Street program office, a visitor center (on Nebraska's Western Trails Historic and Scenic Byway as well as Lincoln Highway Scenic Byway), meeting room, and public restroom facility. Photo: Ogallala Main Street.

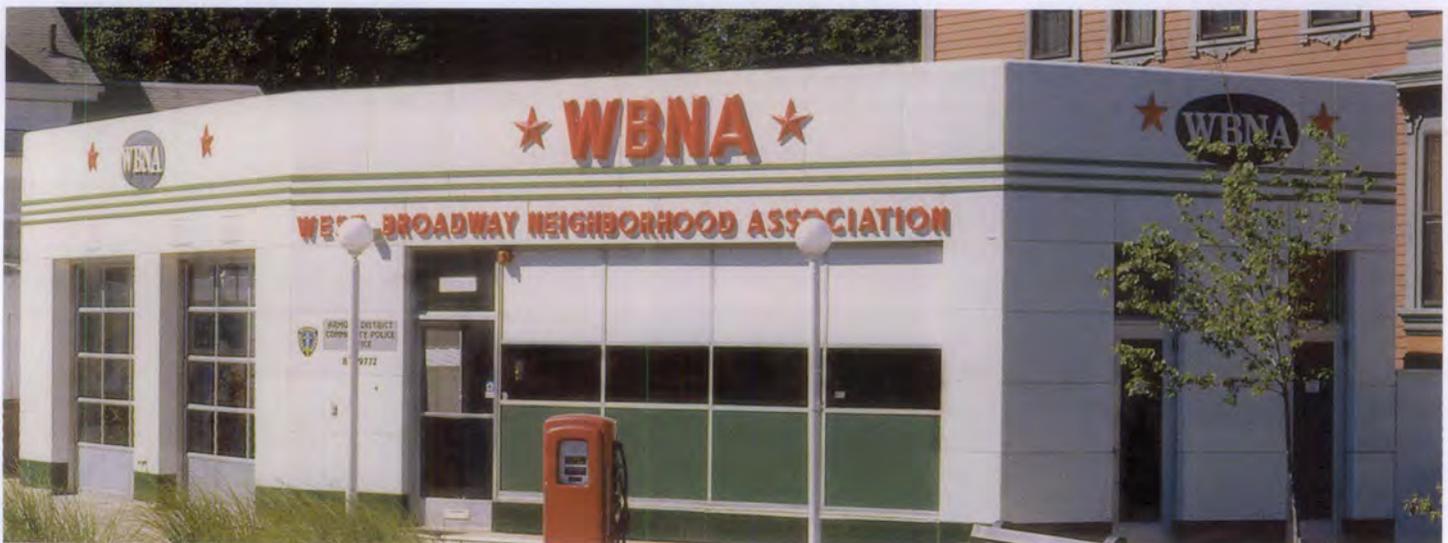
Figure 19. When converted for use as office and meeting space by a local community non-profit, the historic character of this 1960s gas station was retained. Porcelain enamel repairs to this station are illustrated in Figure 11. Photo: Scott Lapham Photography.
