# **FOCUSED BAT SURVEY**

**9850, 9876, 9900, AND 9988 WILSHIRE BOULEVARD  
ONE BEVERLY HILLS OVERLAY SPECIFIC PLAN  
CITY OF BEVERLY HILLS  
LOS ANGELES COUNTY, CALIFORNIA**

LSA Project No. BHL1901-07

November 2020

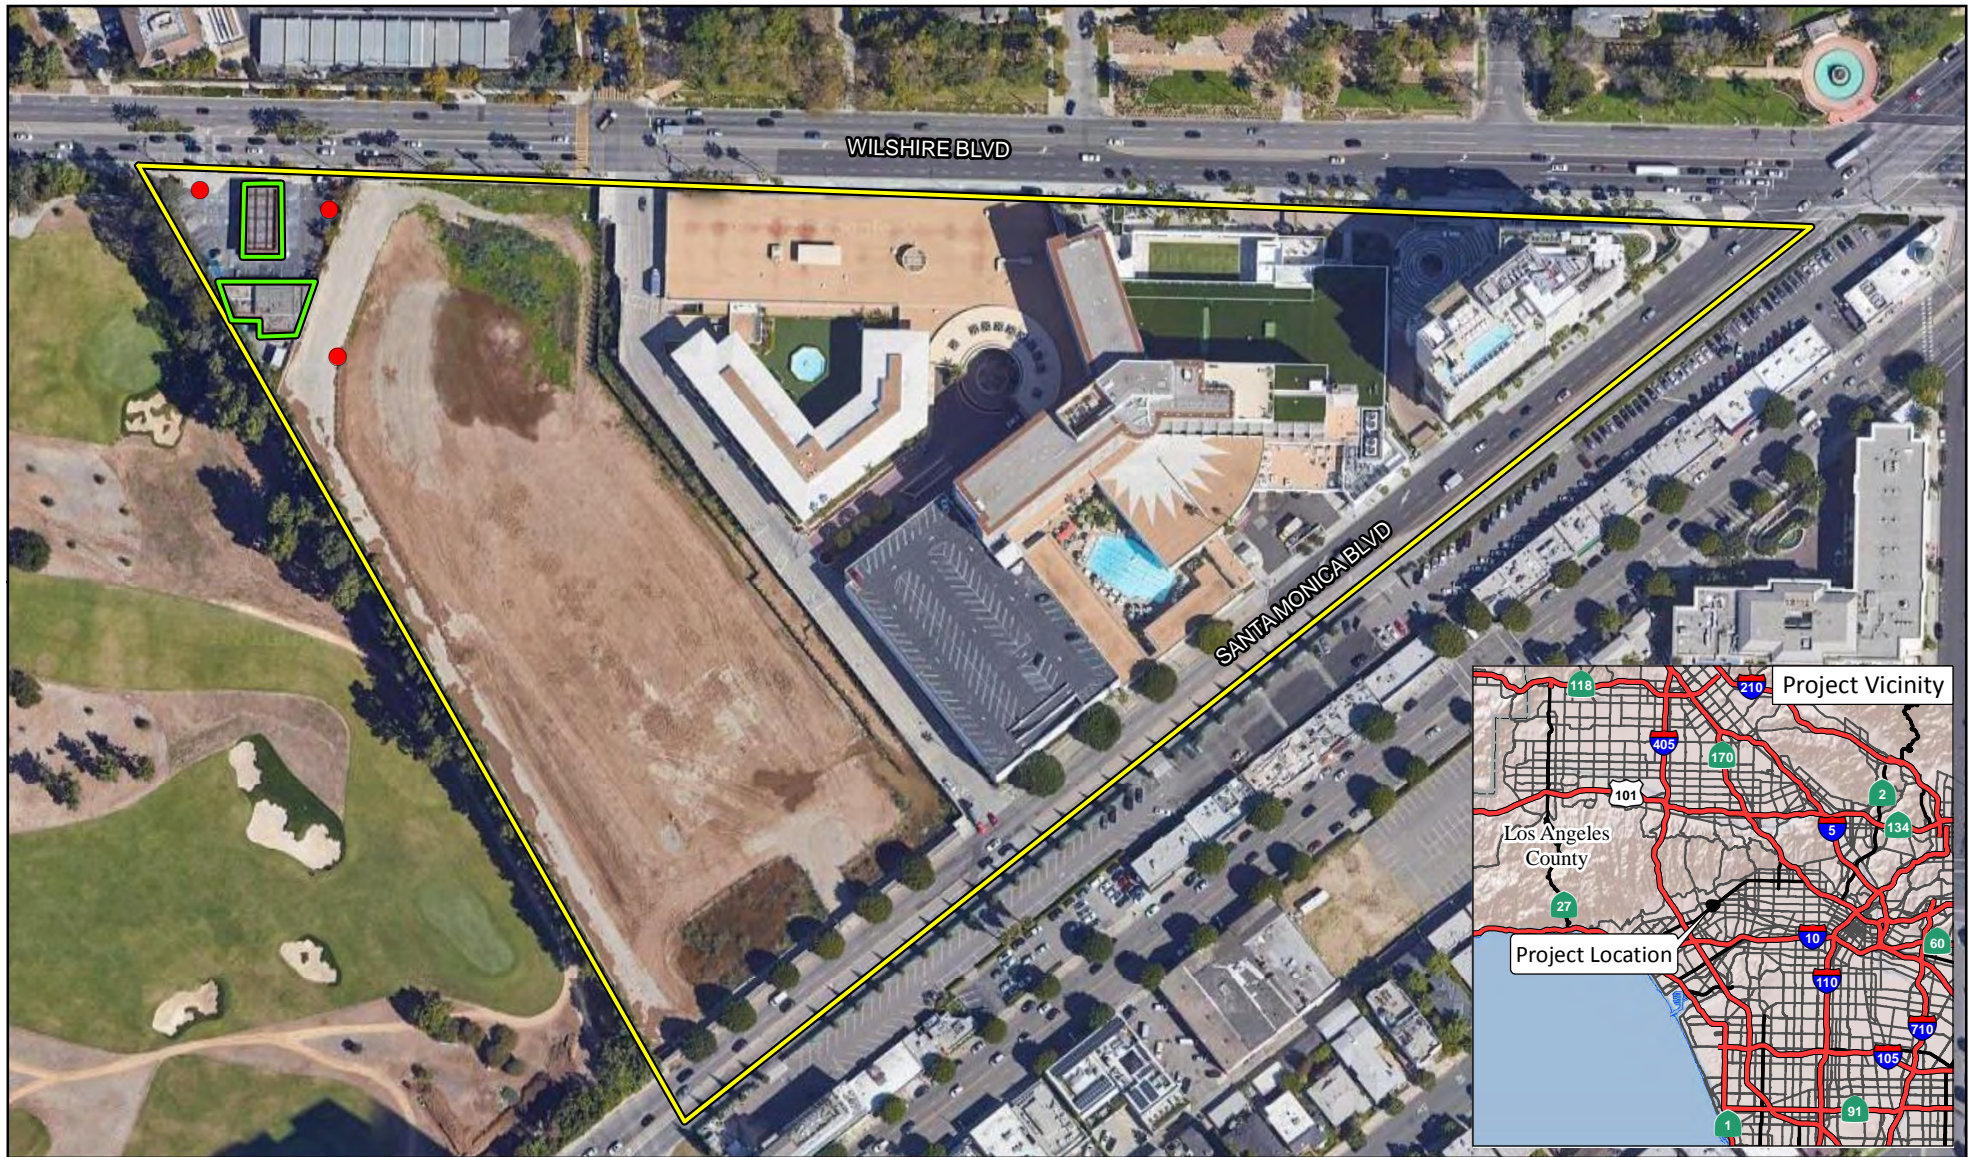
FIGURE 1

Suitable Bat Roosting Habitat Locations and Survey Positions

Figure 1 shows the locations where these detectors were deployed. The acoustic detectors were left in place for the nights of October 2 and October 3, 2020, and retrieved by Ms. Louwsma on the afternoon of October 4, 2020.

The biologists surrounded the gas station and convenience store buildings and watched them for emerging bats to obtain an estimate of the number of bats present (if any), as well as to correlate any recorded acoustic data with visual observations. Figure 1 shows the biologists' positions, which were the same as the acoustic placement locations during the passive acoustic monitoring. When light levels became low enough that it was difficult to see with the unaided eye, all three biologists used night vision goggles (military-grade PVS-7, Generation 3) for observation.

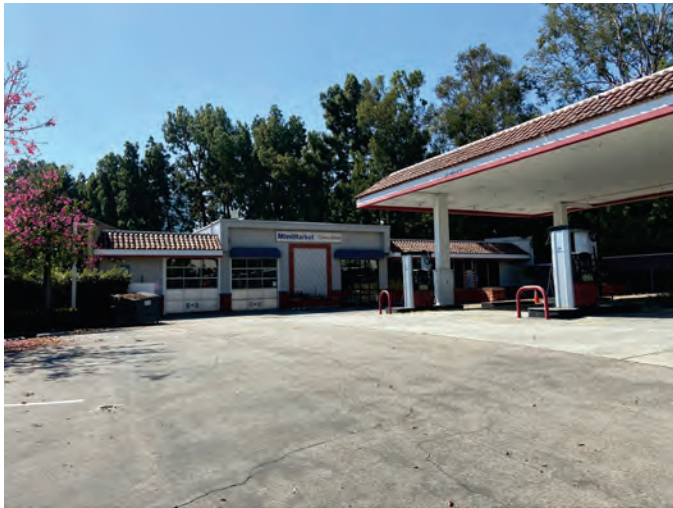
Suitable day-roosting habitat for bats is present in the Spanish tile roofs of the gas station and convenience store buildings located at 9988 Wilshire Boulevard; however, no evidence of roosting was observed. The gas station and convenience store are bordered by a golf course to the west and the vacant 9900 Wilshire property, which is also part of the project area to the east. Although both of these areas could support insect prey and provide foraging habitat for bats, the vacant lot consists primarily of ruderal vegetation with patches of bare ground and is not expected to provide high-quality foraging habitat for bats.

View looking south at the vacant service station buildings located in the site's northwest corner, where suitable bat day-roosting habitat is present in the Spanish tile roofs. Mature trees from the golf course property are visible in the background.

- If demolition is scheduled outside of the bat maternity season (April 1–August 31), a pre-construction clearance survey may be conducted within two weeks of demolition of the service station buildings to determine whether bats are roosting. If bats are present, a qualified bat biologist shall install or directly supervise installation of humane eviction devices and exclusionary material as described below. If bats are confirmed absent, the buildings may be removed.

- Prior to demolition of the Spanish tile-roofed buildings, a qualified bat biologist shall install or directly supervise installation of humane eviction devices and exclusionary material to evict bats that are present and to prevent bats from roosting in the buildings. Implementation of the humane eviction/exclusions is typically performed in the fall (September or October) preceding construction activity at each structure to avoid impacts to hibernating bats during the winter months or during the maternity season (typically from April 1 through August 31 in Southern California), when flightless young are present. Humane evictions/exclusions cannot be performed during the bat maternity season because this would result in “take” of juvenile bats, and should be avoided during the winter because bats are not consistently active and may be hibernating. Any humane eviction/exclusion devices must be installed at least 10 to 14 days prior to the demolition of a structure housing bats to allow sufficient time for the bats to vacate the roost(s).

- Replacement bat roosting habitat structures shall be installed on site. The design of these structures shall be developed in coordination with a bat biologist who has experience designing roosting habitat mitigation to ensure that appropriate crevice sizes and adequate thermal characteristics are included in the specifications. These habitat structures can often be designed and fabricated to create a decorative aesthetic while also meeting the ecological needs of the target bat species. The aspect and location of the roost structures shall also be determined in coordination with a bat biologist.

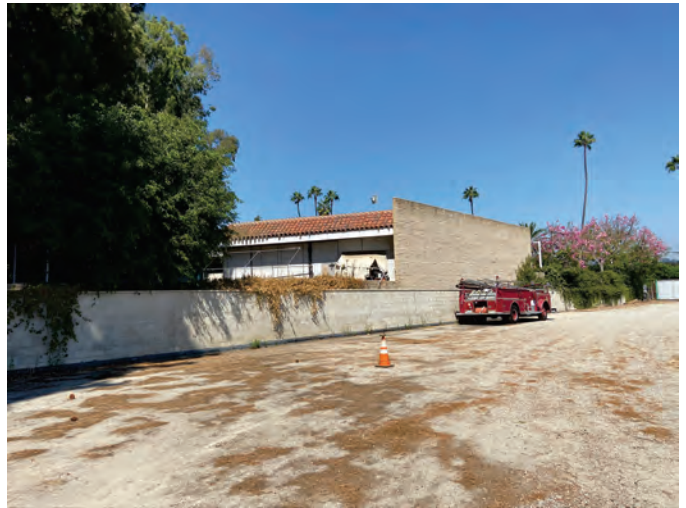
View looking northwest from the vacant lot toward the back side of the vacant service station buildings, where suitable bat day-roosting habitat is present in the Spanish tile roofs. Mature trees from the golf course property are visible in the background.

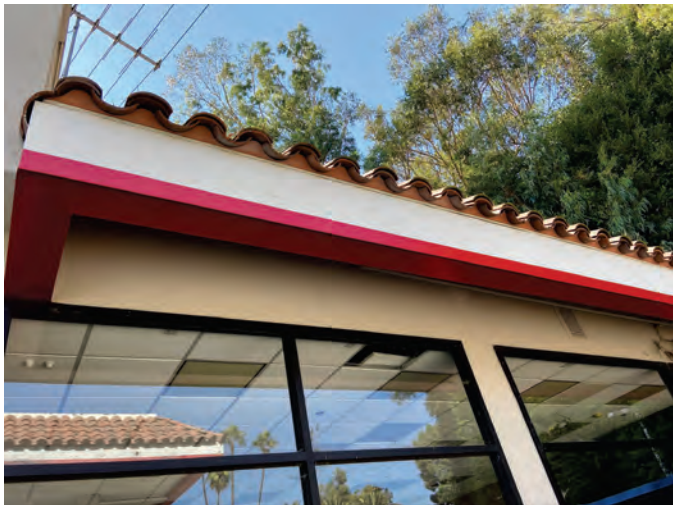
Closer view of the crevices between the Spanish tiles, which are suitable for use by roosting bats including maternity colonies.

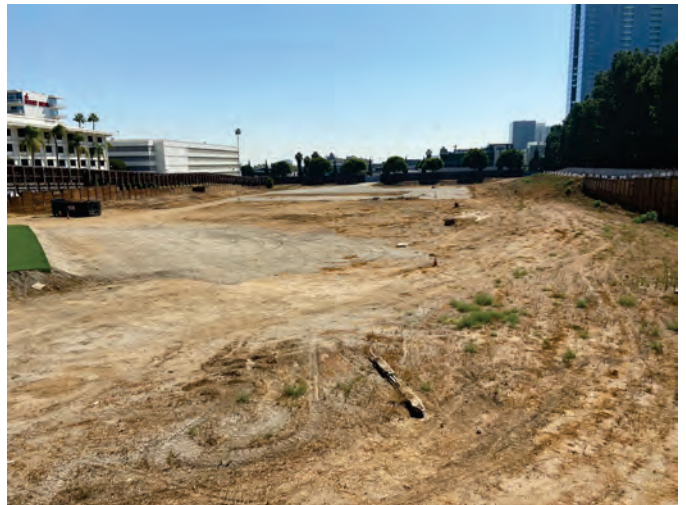
View looking south at the vacant lot from its northwestern corner. The lots consists primarily of bare ground with some ruderal vegetation.

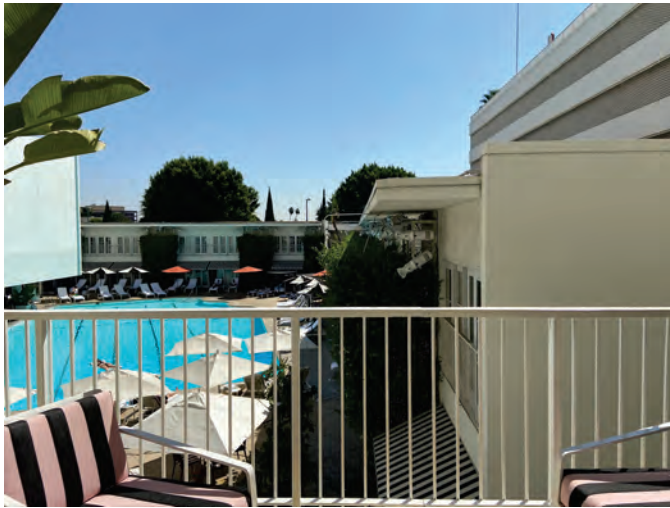
Representative view of some of the buildings near the swimming pool that are proposed for demolition. The architectural design of these buildings lack crevice and cavity features suitable for use by roosting bats.

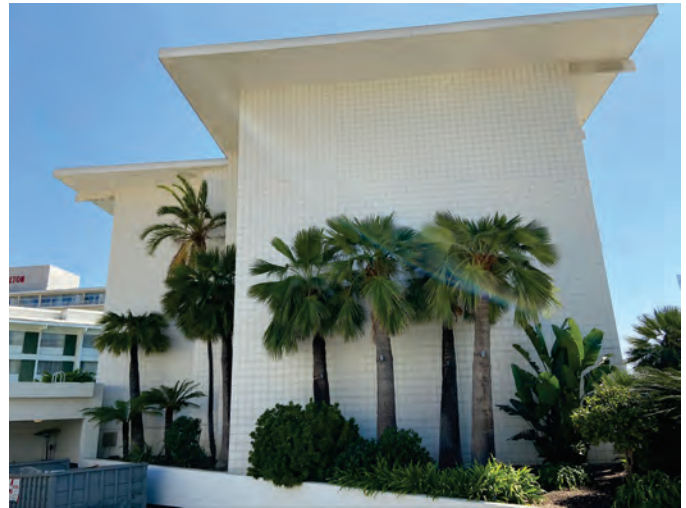
Representative view of a typical design of other buildings on site that are proposed for demolition. The architectural design of these buildings lack crevice and cavity features suitable for use by roosting bats.

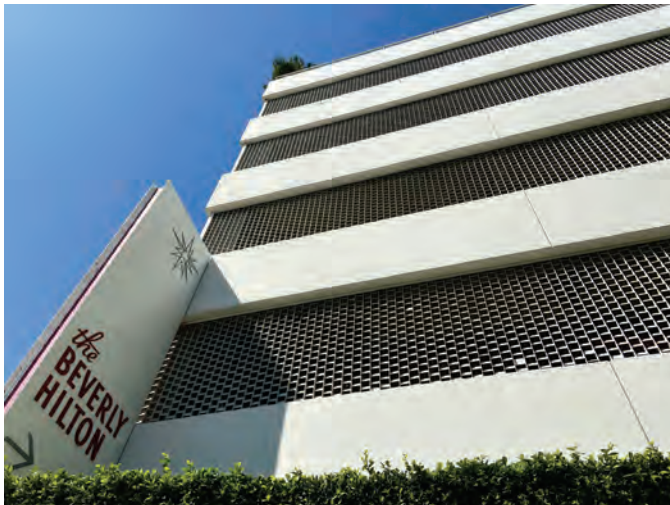
Representative view of the aboveground parking structure that is proposed for demolition. The architectural design of this building lack crevice and cavity features suitable for use by roosting bats.

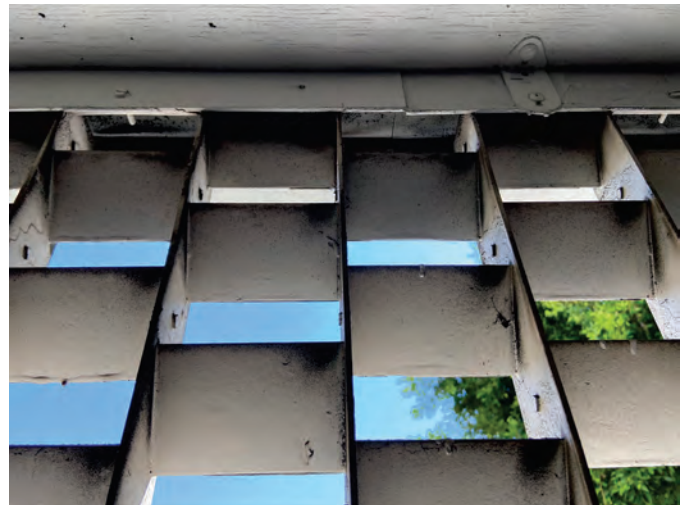
Closer view of the structural features of the parking structure that is proposed for demolition. Although there are elements that provide entry and exit points, the structural features lack suitable crevice and cavity features for roosting bats.
