## CIVIC CENTER DRIVE TREE ASSESSMENT

### TREE REPORT

**CIVIC CENTER DRIVE  
Beverly Hills, CA**

**August 22, 2015**

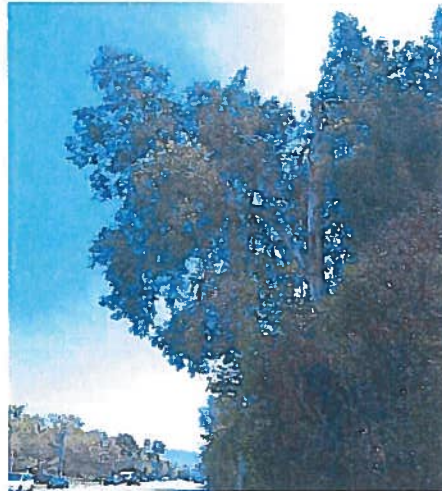
Lot 12, Santa Monica Blvd.

Unlike the Chinese Elms, the Eucalyptus reside along Santa Monica Blvd. outside of the fence. These trees overhang the street. The trunks of the trees stand very close to the roadway, and some have deflected the adjacent curb, or grown over it.

As a result of their close proximity to the street the Eucalyptus along Santa Monica Blvd. lack a balanced root zone. They also harbor multiple structural defects including weak branch attachments and excessive end weight. Many remnant trunk stumps remain from Eucalyptus already removed, and the remaining trees have either suffered branch failures in the past or harbor hanging limbs now. (See images in Appendix)

In the immediate term a number of dangerous, defective branches overhanging both Santa Monica Blvd. and Civic Center Drive should be removed for protecting the public.

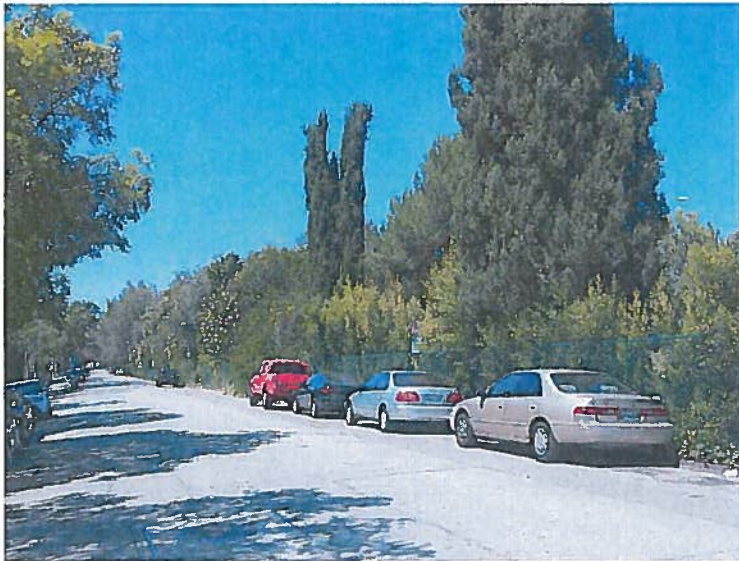
At the far easterly portion of Lot 13, along Civic Center Drive no trees exist. Rather a row of mixed ornamentals (Ficus, Cypress, Hibiscus, etc.) exist inside of the chainlink fence. No sidewalk exists at this portion of the parcel. These plants are rather tidy and do not

*Mixed ornamentals along Civic Center Drive, to the east*

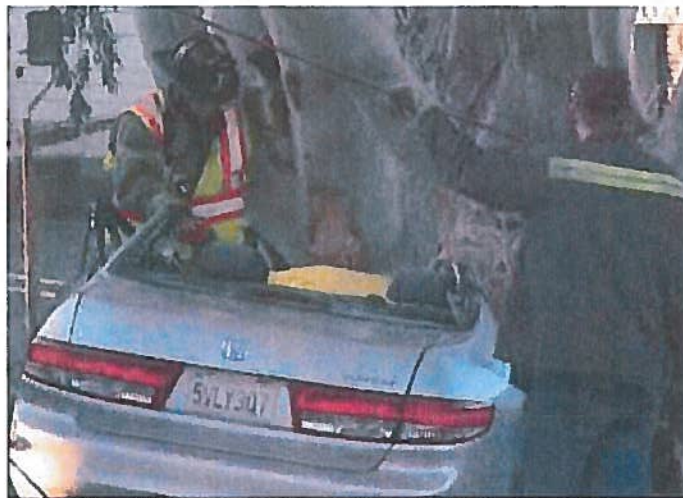
Virtually all of the trees running along Santa Monica Blvd. have the potential to harm either person or property, and in fact many of them already have. Additionally, the remaining large Desert Gum Eucalyptus on Lot 12 that lay immediately adjacent to the street add the potential of being struck by an automobile.

*Lodi vehicular impact with a Eucalyptus adjacent to the street*

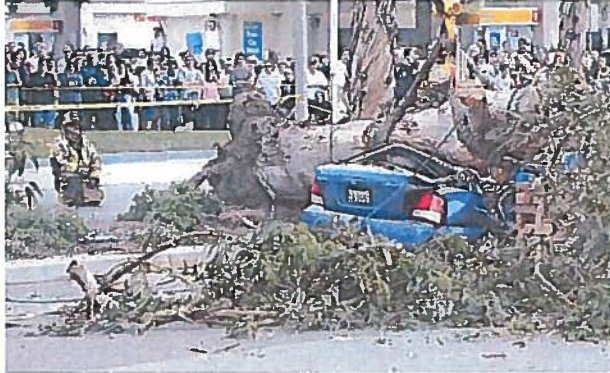
Large trees planted adjacent to streets, and thereby with unbalanced root zones are less stable than those with balanced root zones. In the case of all of the visible stumps of already demolished trees however, none appear to have yet failed at their root zone.

*Eucalyptus failure from unbalanced root zone**Trunk/Root Rot Failure Concern:*

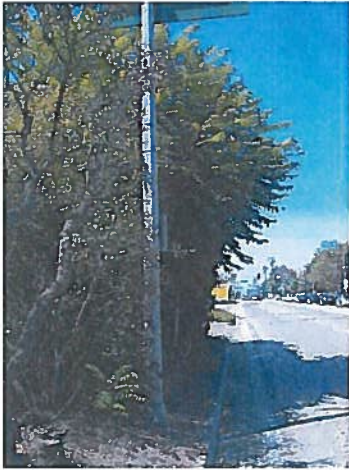
**Ailanthus**

The nuisance tree is the *Ailanthus altissima* at the west corner of Lot 12. This species readily spreads by movement of its very fine textured seed. The seed can spread by wind, or via bird droppings. Some believe it was brought to the Americas and to Europe via Chinese laborers constructing rail lines. Some suspect that the fine seeds embedded themselves in the pockets of these laborers and spread when clothing was washed in rivers adjacent to the rail lines. It is true that this species can be observed along train routes in both Europe and North America. This species is designated as *INVASIVE* by both the United States, and California.

Furthermore, one extremely invasive species (Tree of Heaven) should be removed immediately to preclude its spread to surrounding properties.
